CYPREMORT RENOVATIONS 2021

BEFORE AND AFTER

SUBMITTED BY MARGARET TODD

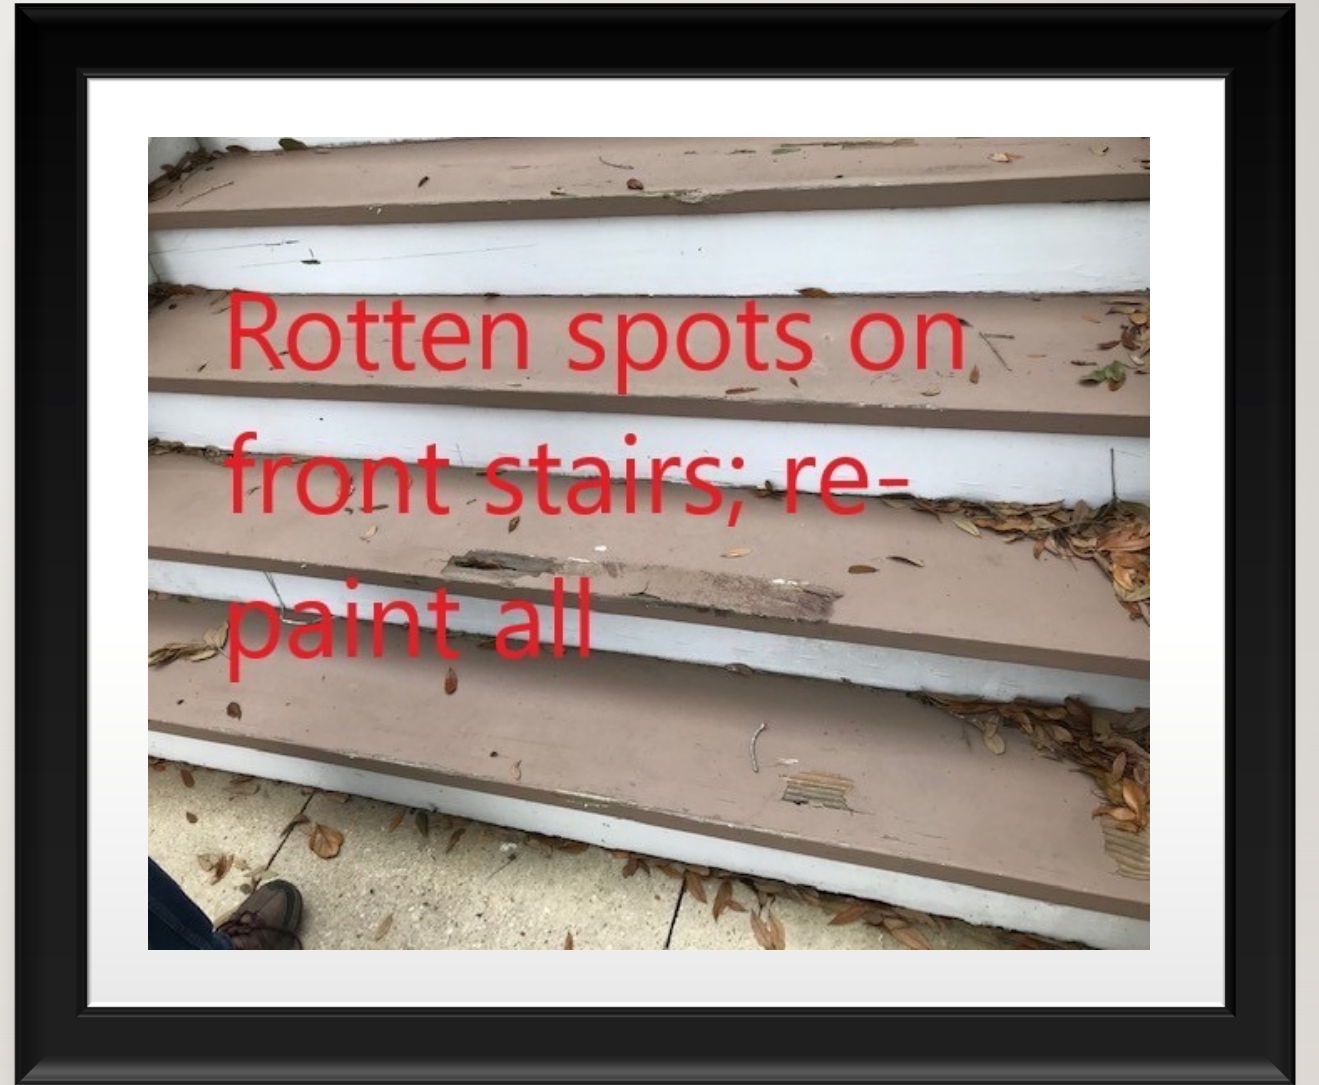
FRONT STAIRS

- The front, main staircase was rotten due to the multiple storm surges that submerged it in salt water for many hours over recent years.
- A few bottom steps collapsed shortly after this photo was taken.

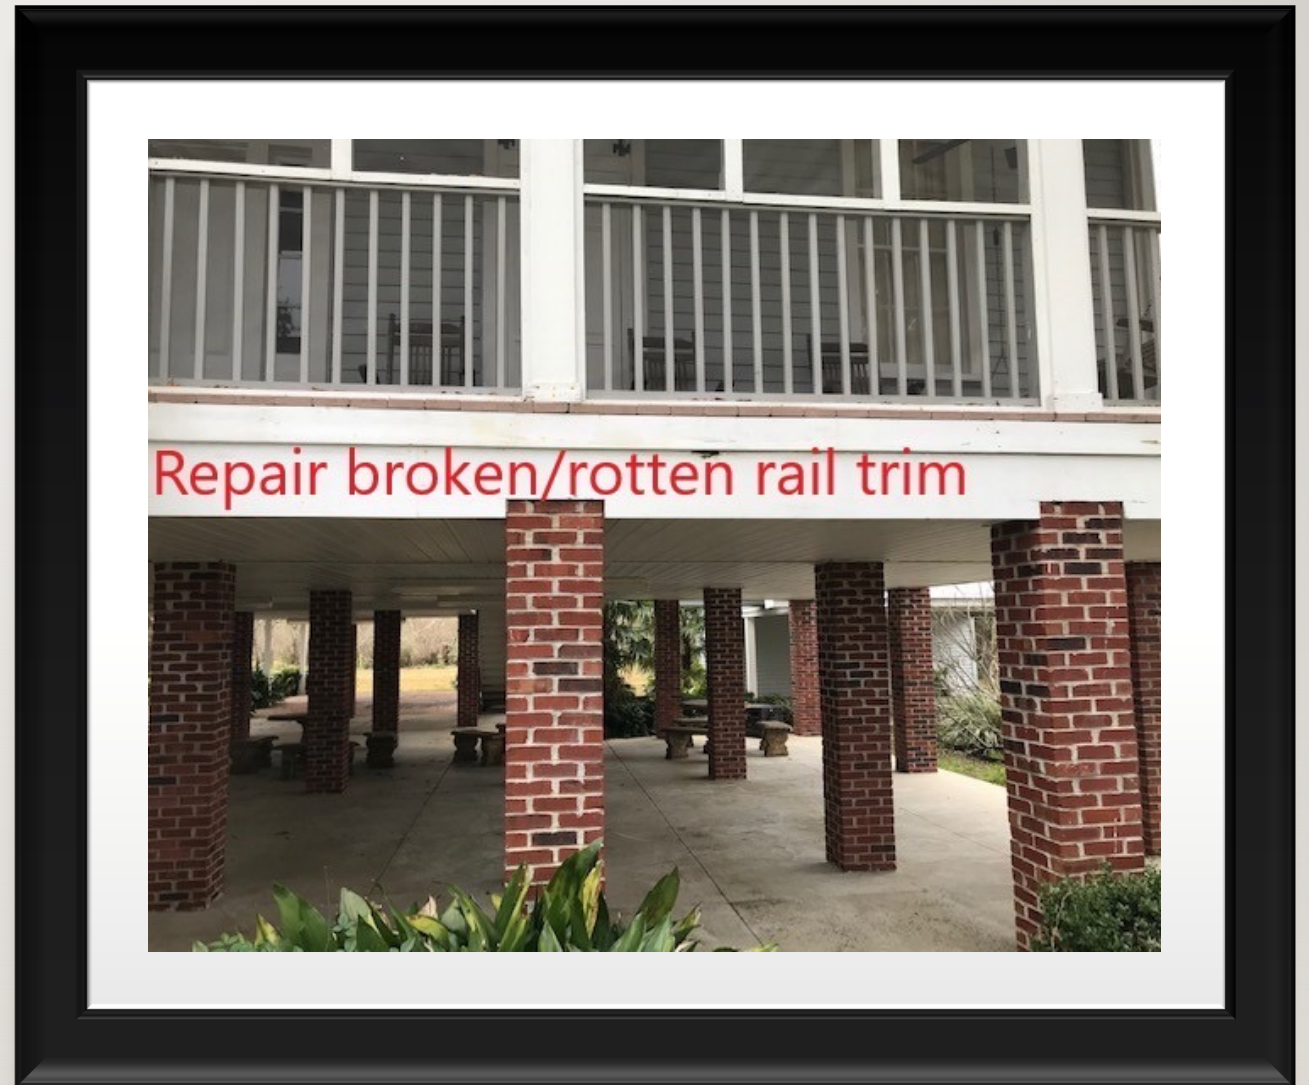
SCREEN PORCH

- Handrails and trim were rotten.
- Unstable when pushed on.
- Vertical supports had rotten bases.

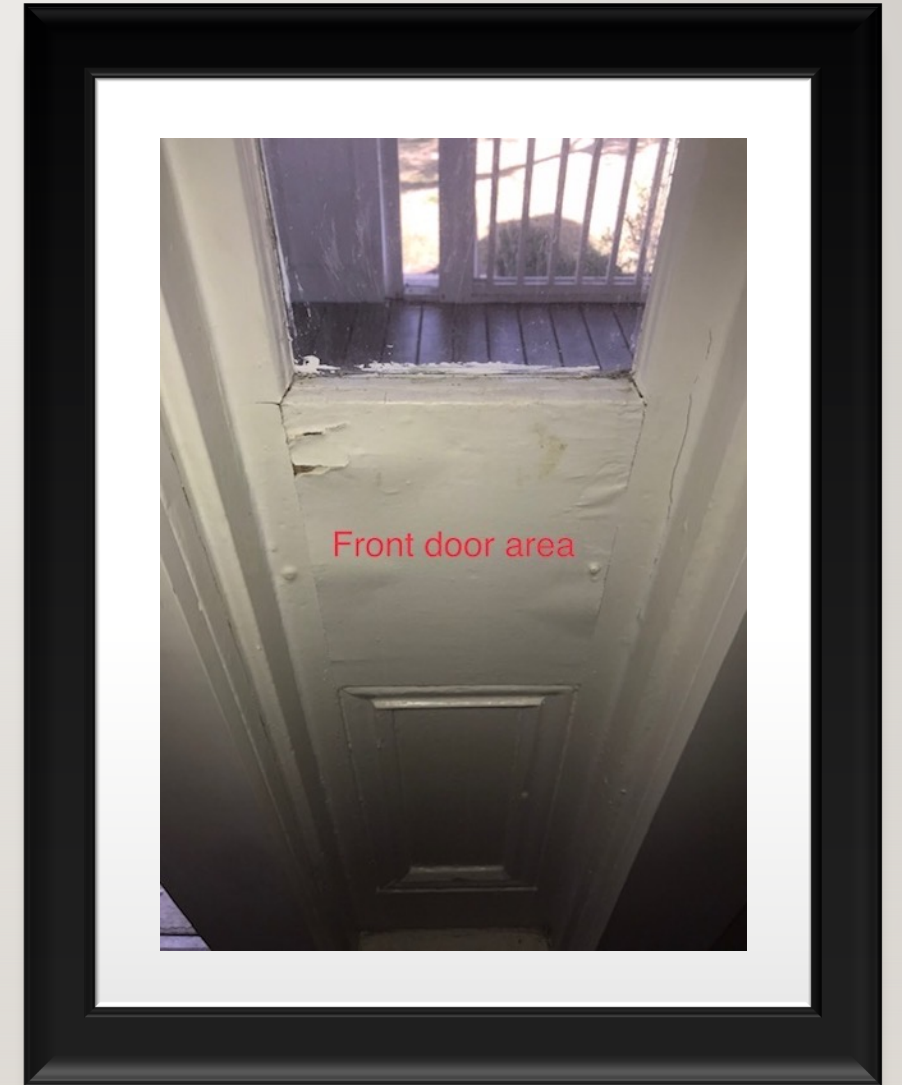
FRONT DOOR INTERIOR

- The door and sides had severe, peeling paint.
- Cracks around the perimeter of the door let in sunlight and heat.

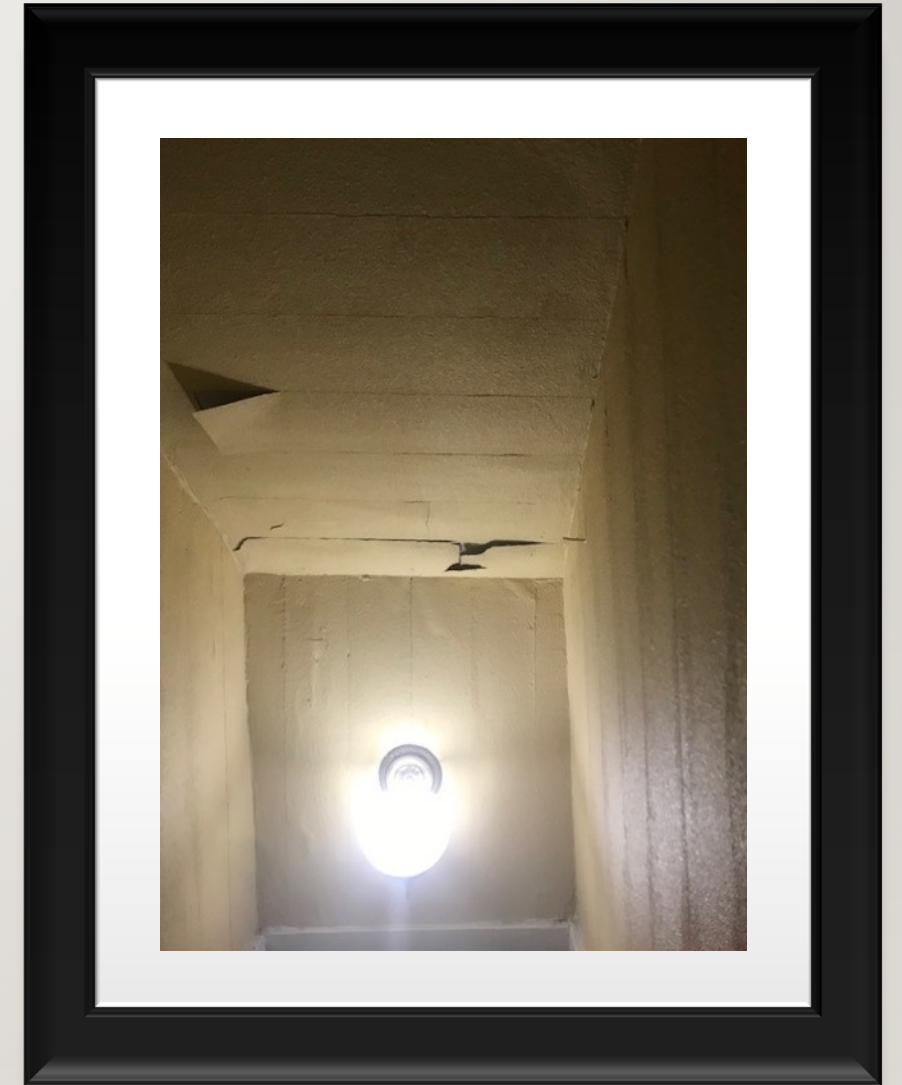
INTERIOR STAIR WALL

- Previously, many, layers of paint were peeling from the ceilings and walls.

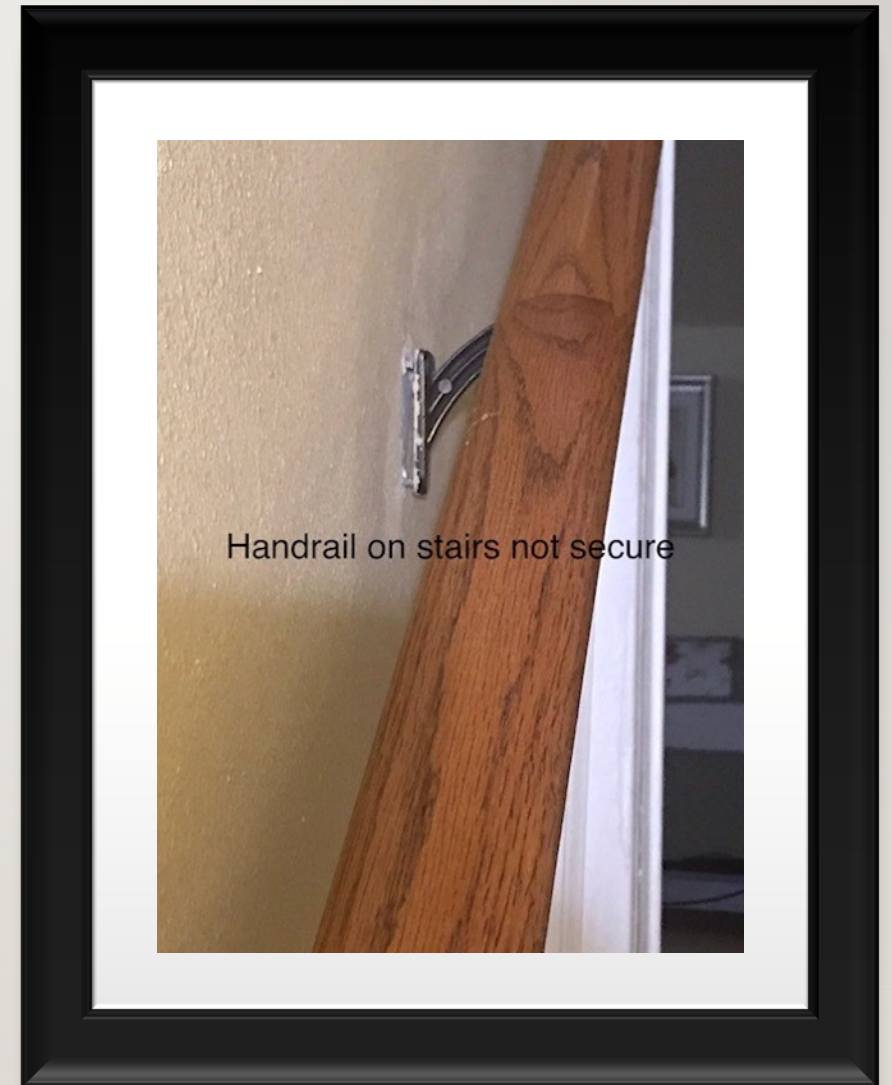
INTERIOR STAIR HANDRAIL

- The stair handrail was detaching from wall.

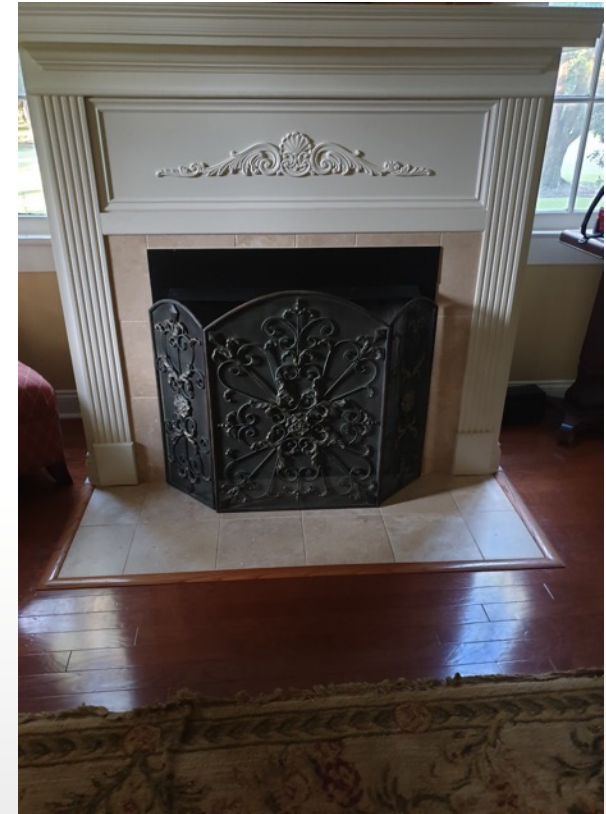
FIREPLACE

Cathy Eagan, on behalf of the Family Council, requested that the gas plumbing assembly in the fireplace be removed for safety as it is, often, unoccupied, and could lead to a fire if, accidentally, left lit. It was requested an electric unit be installed.

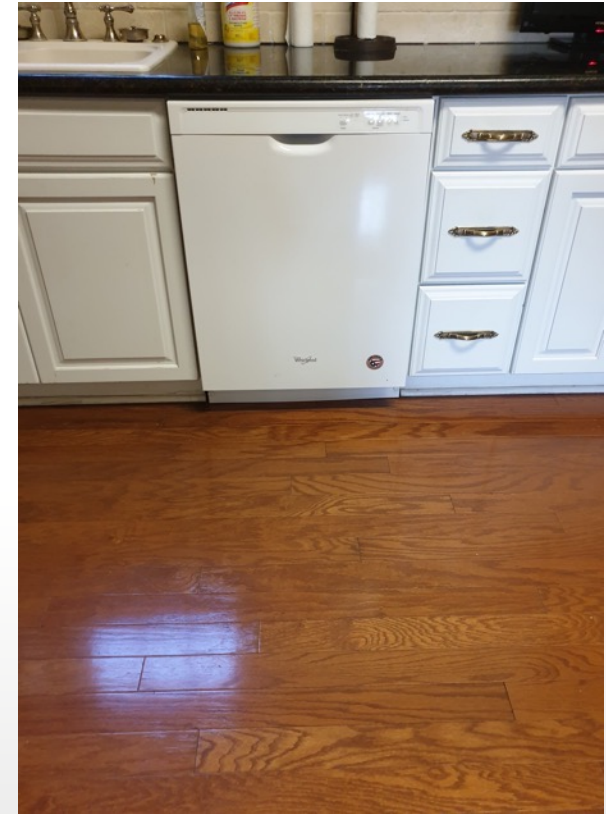
DISHWASHER

- The dishwasher was, never, installed properly. So, it was not anchored to the cabinetry and would move when opened.
- A flange was mounted under the countertop ledge to hold it in place.
- A new supply line and valve were installed to replace the old leaky one.

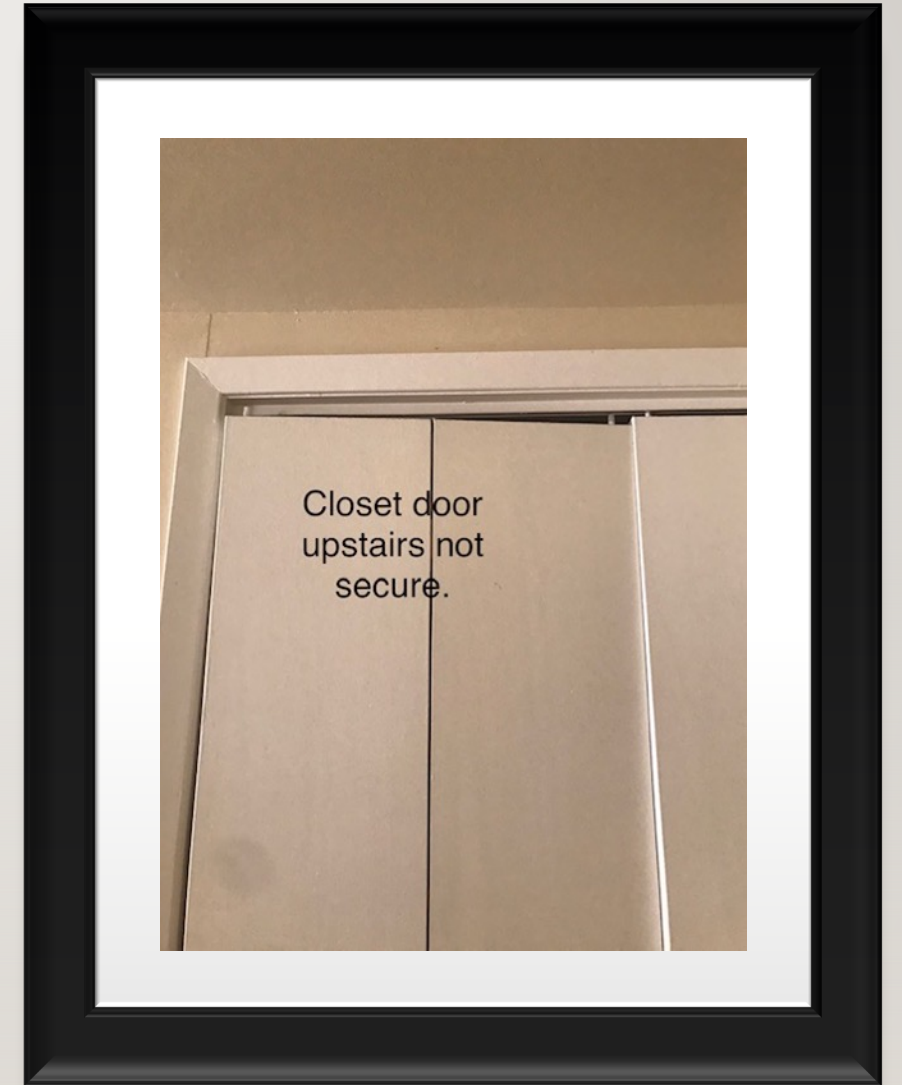
CLOSET DOOR

- The upstairs, bedroom closet door was not secure and would fall off the track, and forward.

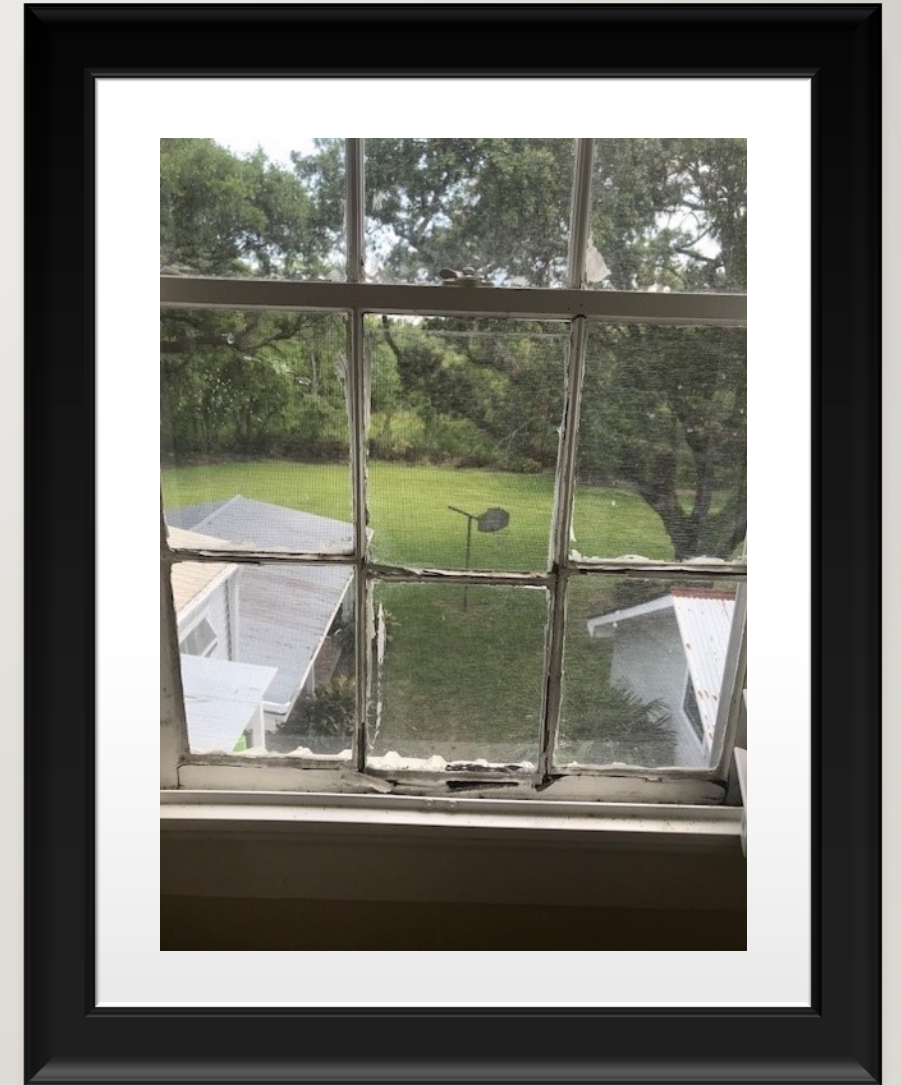
BEDROOM WINDOW

- The upstairs, bedroom dormer window had rotted out to the extent that the panes slipped downward and left a $\frac{3}{4}$ -inch opening for rain to get in.
- Water spots were on the bedroom ceiling below.

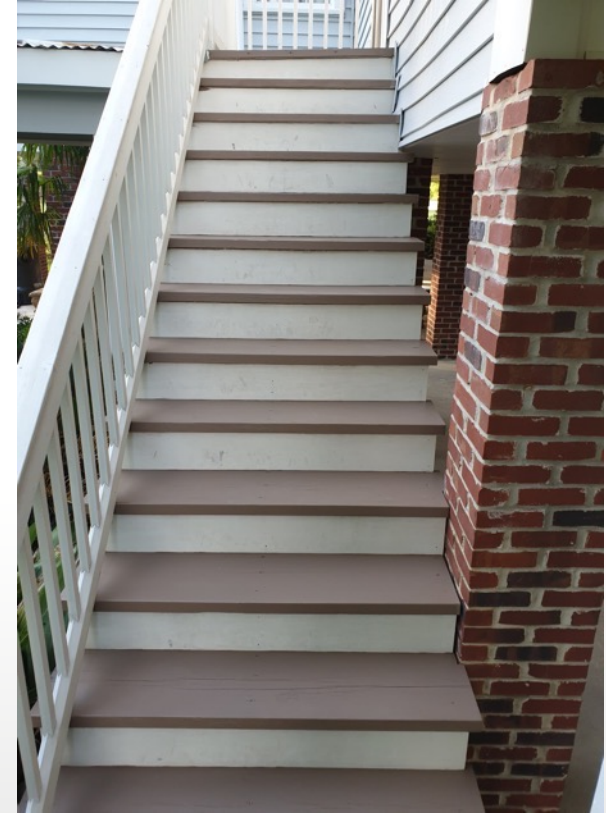
BACK STAIRS

- The stair treads were repainted.
- Top landing had an, “unstable, bouncy,” feel that was reinforced from underneath.

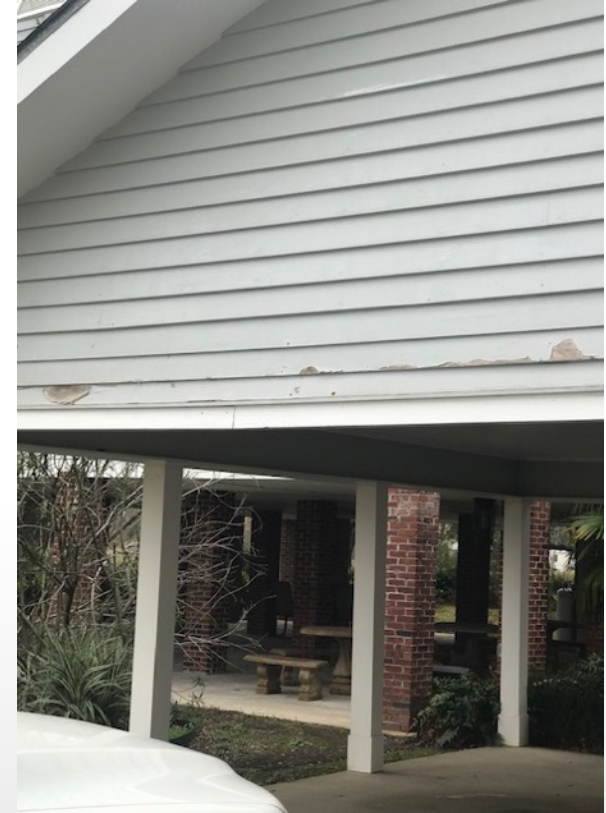
GARAGE GABLE

- The siding on the garage gables were peeling.
- There was evidence of rot along the fascia board below the siding, too.

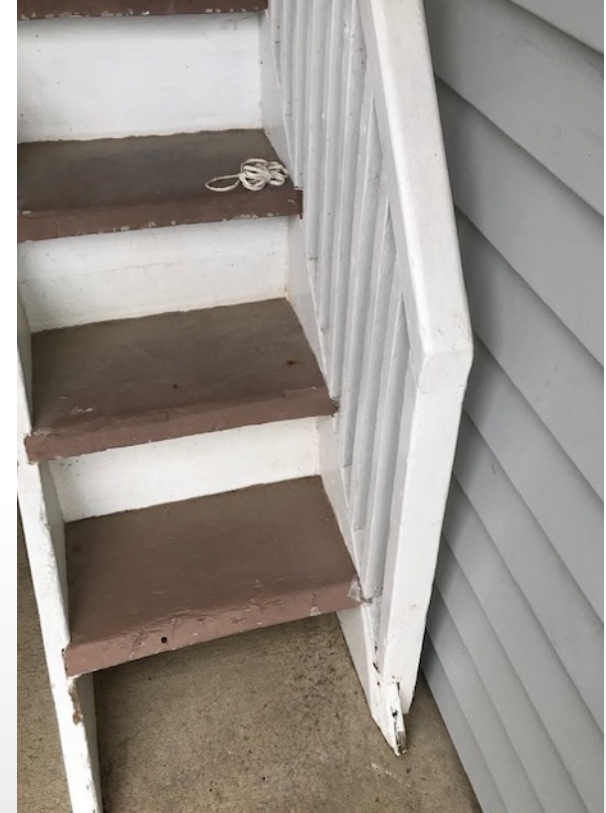
OUTDOOR STORAGE STAIRS

- The handrail to the outdoor storage area was wobbly.
- Added a block to secure the handrail to the side wall.

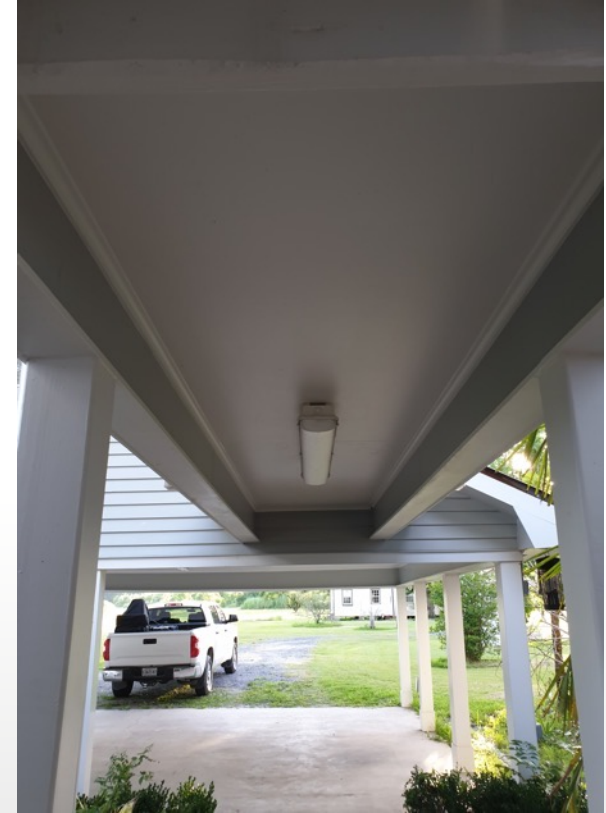
BREEZEWAY CONNECTOR

- Water intrusion from the stairway landing caused rot on the plywood ceiling.
- Added a sheet metal flashing to direct the water over towards the outsides. Therefore, the water can not be absorbed into the plywood.
- Replaced and painted plywood. Sealed all surfaces.

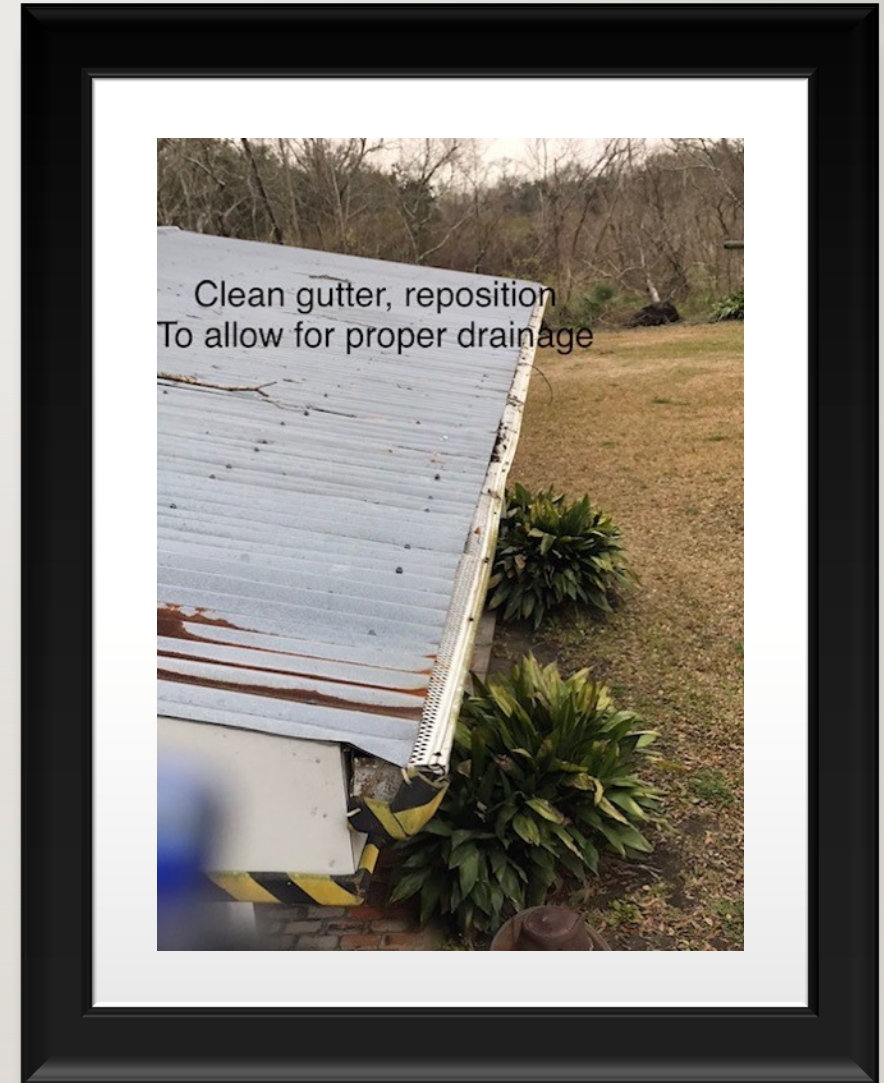
GUTTER OVERFLOW

- Rainwater runoff was overwhelming the gutter and spilling over side.
- Gutter was repositioned with additional flashing to accommodate and redirect waterflow through channel and not over the edge.

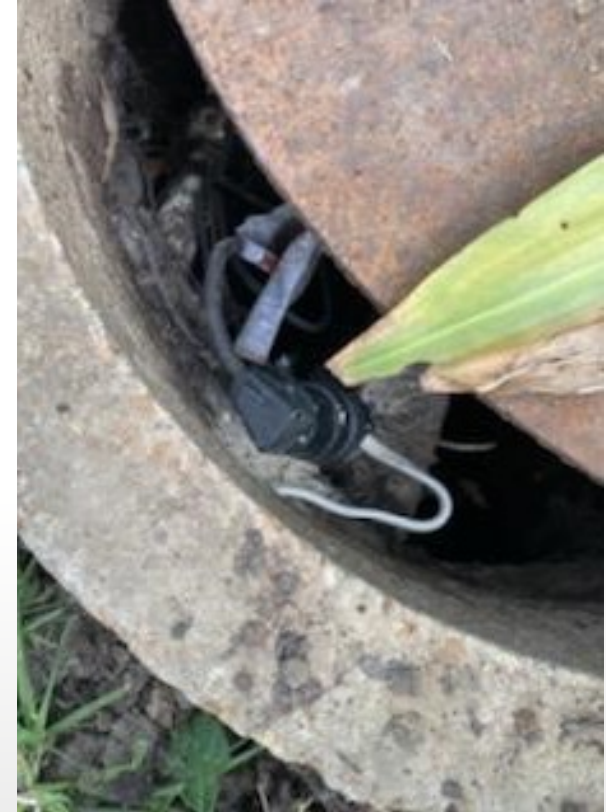
SEWER SYSTEM & ELECTRICAL REPAIRS

- The sewer treatment plant was not functioning.
- The sewer repairman determined there was no electricity feeding it.
- An electrician was called to complete the repair.
